Doc. No.: P3VSB000003

VENDOR SERVICE BULLETIN ATA 26-24 FIRE PROTECTION – FIRE EXTINGUISHER HIGH TEMPERATURE EXPOSURE - GENERAL

PART MANUFACTURER	umlaut engineering GmbH	
AFFECTED PART	Hand-held Fire Extinguisher HAFEX, model type: P3APP003010A P3APP003010B P3APP003010C

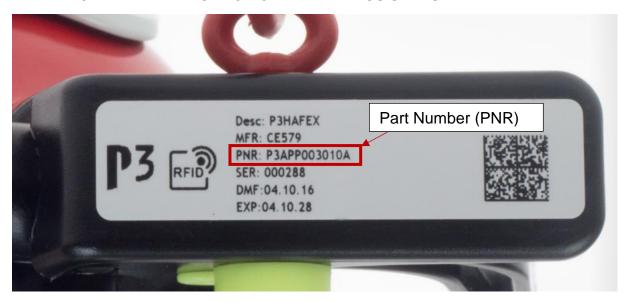
Figure 1: RFID Label.

1. On the RFID label located on the lever of the fire extinguisher, check the part number (PNR). Only PNR P3APP003010A, P3APP003010B, P3APP003010C are subject to this service bulletin. (refer to Figure 1).
