VENDOR SERVICE BULLETIN ATA 26-24 FIRE PROTECTION – FIRE EXTINGUISHER -HIGH TEMPERATURE EXPOSURE - INSPECTION

| PART MANUFACTURER | umlaut engineering GmbH | | |
|---|--|--|--|
| AFFECTED PART | Hand-held Fire Extinguisher HAFEX, model type: P3APP003010A P3APP003010B | | |

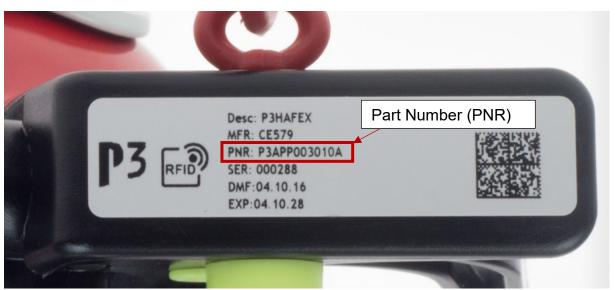
Figure 1: RFID Label.

On the RFID label located on the lever of the fire extinguisher, check the part number (PNR). Only PNR P3APP003010A, P3APP003010B, P3APP003010C are subject to this service bulletin. (refer to Figure 1).
